# Historic Design Guidelines

Borough of Glen Ridge  
Historic Preservation Commission

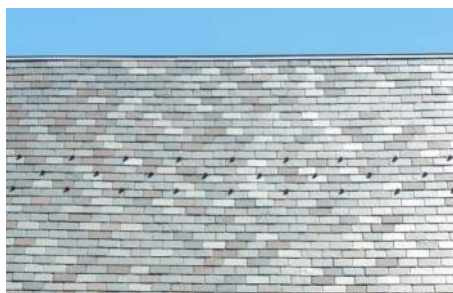
Slate varies in color, shape, texture, and details. Selective in-kind replacement from the same geologic formation is appropriate.

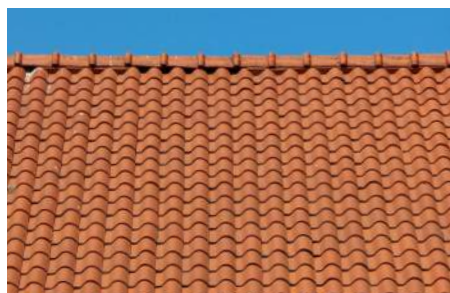
Terra cotta tile and clay should be preserved whenever possible. Selective in-kind replacement is appropriate.

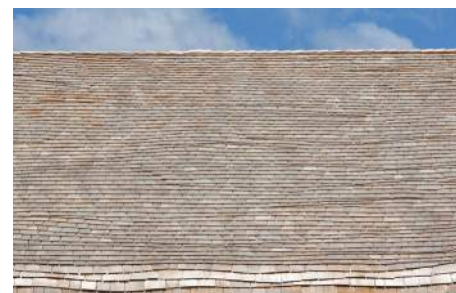
Wood shingle can be replaced with dressed wood shingle. The use of pressure-treated fire-resistant wood shingles is appropriate.

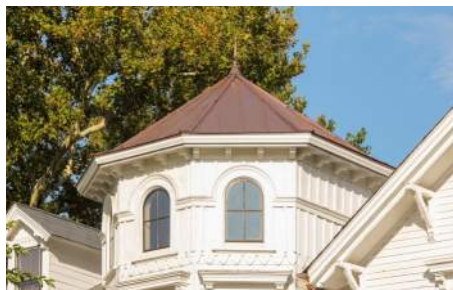
Metal roofs should be replaced to match the type, appearance, trim, and articulation of the original. Copper and painted terne are typically appropriate materials.

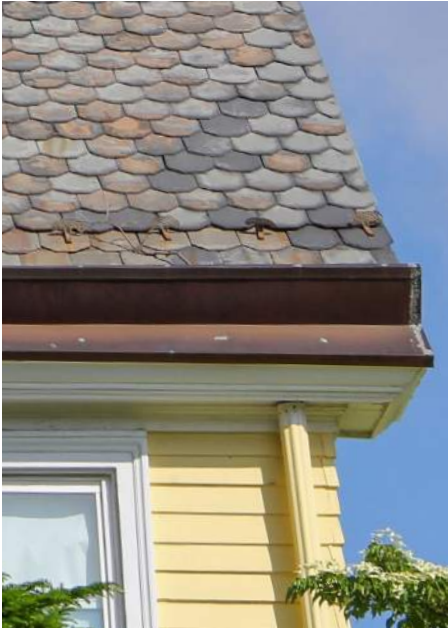
Lined pole gutter

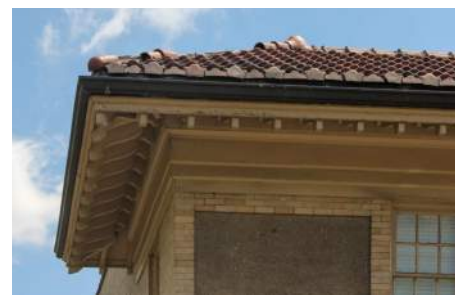
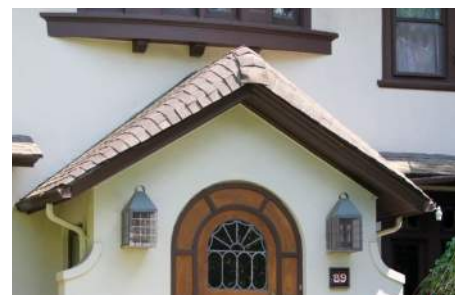
Above: Wide overhanging eave  
Below: Rounded eaves simulate thatching

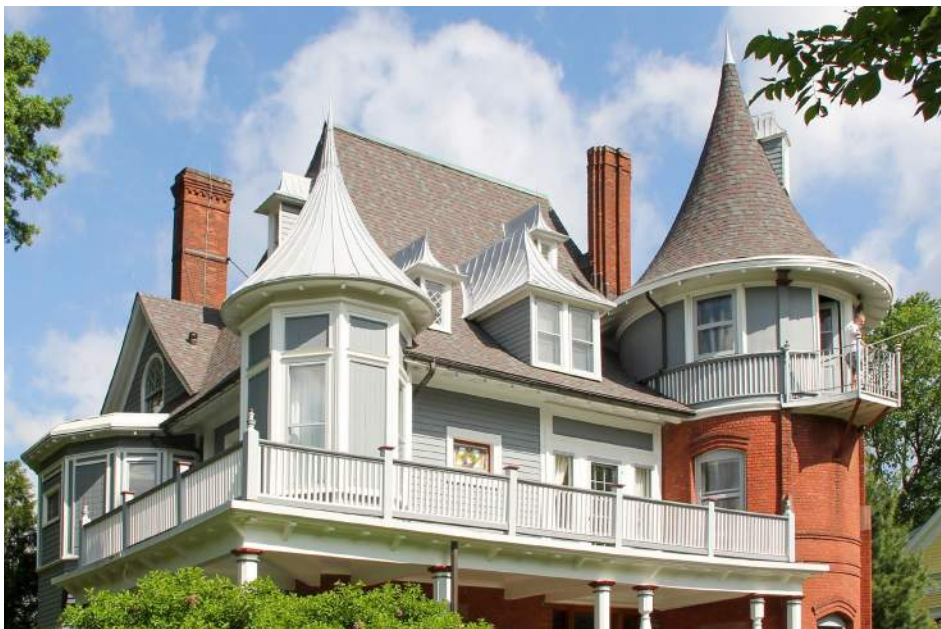
The roof of 74 Douglas Road is punctured by hipped dormers of various sizes and corbelled brick chimney stacks. Simple finials cap the round and octagonal towers.

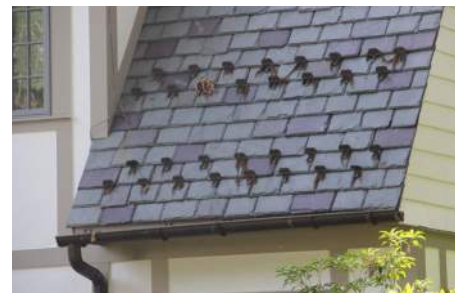
Snow birds

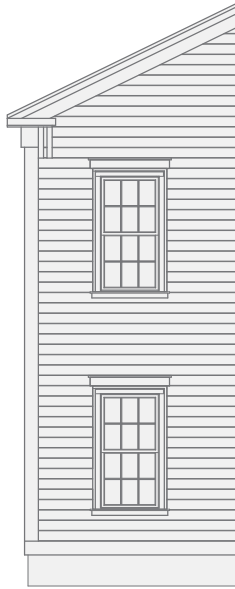
✓ Appropriate corner boards for board sidings on Second Empire, Queen Anne, and most Colonial Revival style houses.

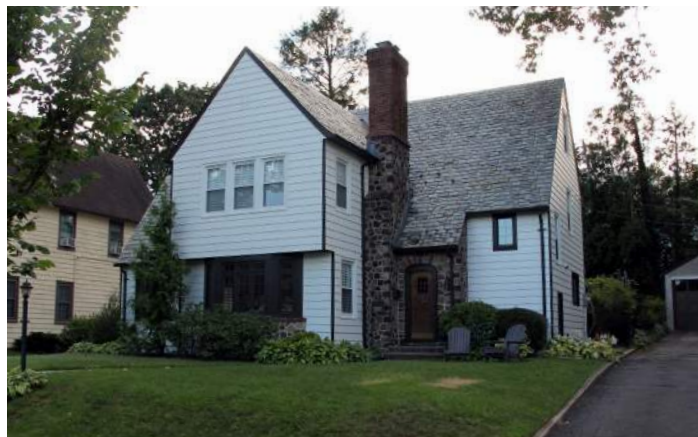
124 Stonehouse Road with stucco and half-timbering concealed by metal siding, prior to restoration project

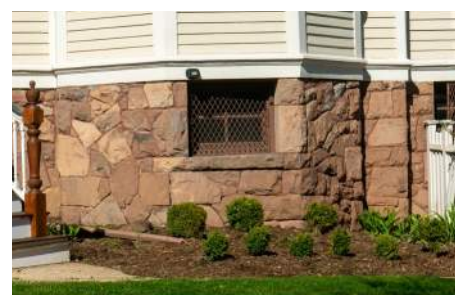
Rubble stone foundations are common in early Glen Ridge homes

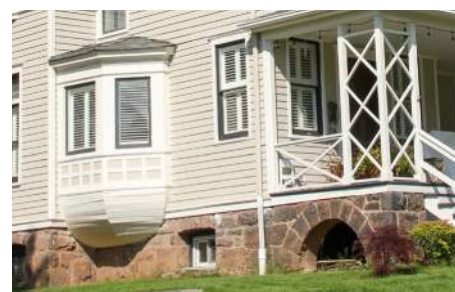
Foundation is articulated under front porch

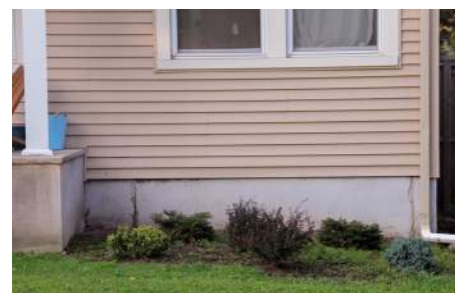
✗ Inappropriate exposed concrete foundation

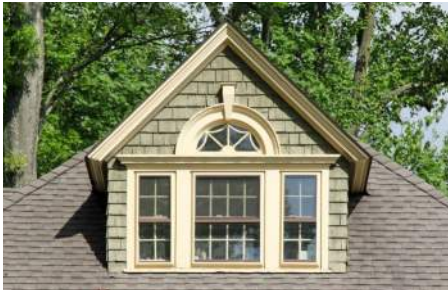
Palladian window with a central arch flanked by two double-hung windows

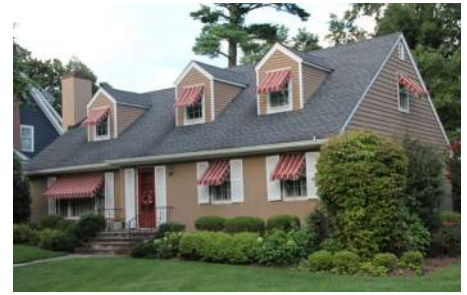
Awnings installed in a reversible manner

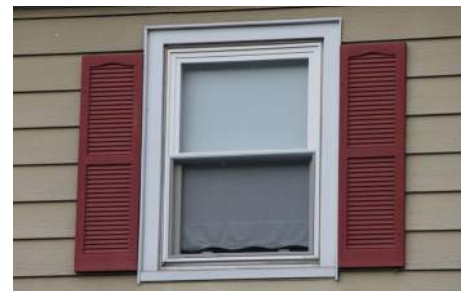
✗ Reducing the historic daylight opening of a window is not appropriate

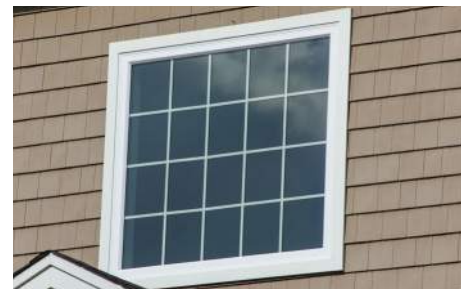
✗ Integral or snap-in muntin grilles with no profile on the exterior side are not appropriate

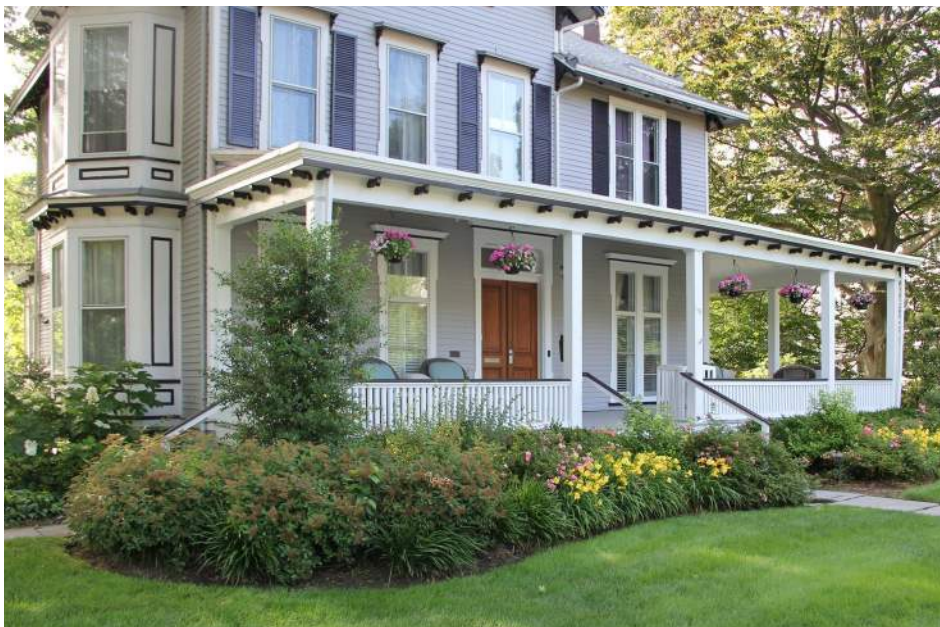
Bracketed box cornice and tightly-spaced balusters across the front porch are some of the Victorian details of 79 Forest Avenue

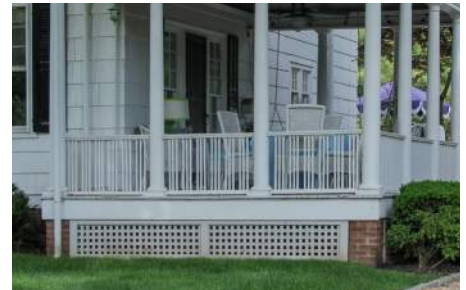
Framed square lattice below tightly-spaced balusters

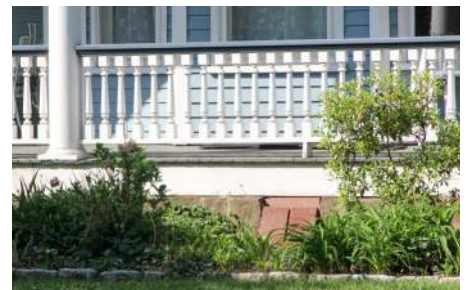
Some porches have stone foundations which support the wood frame and deck

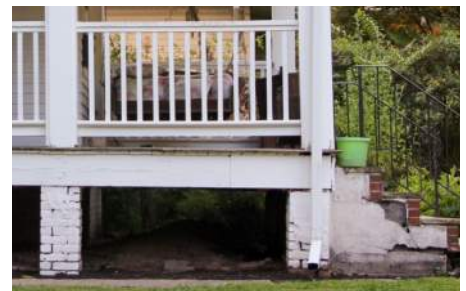
✗ Inappropriate open piers

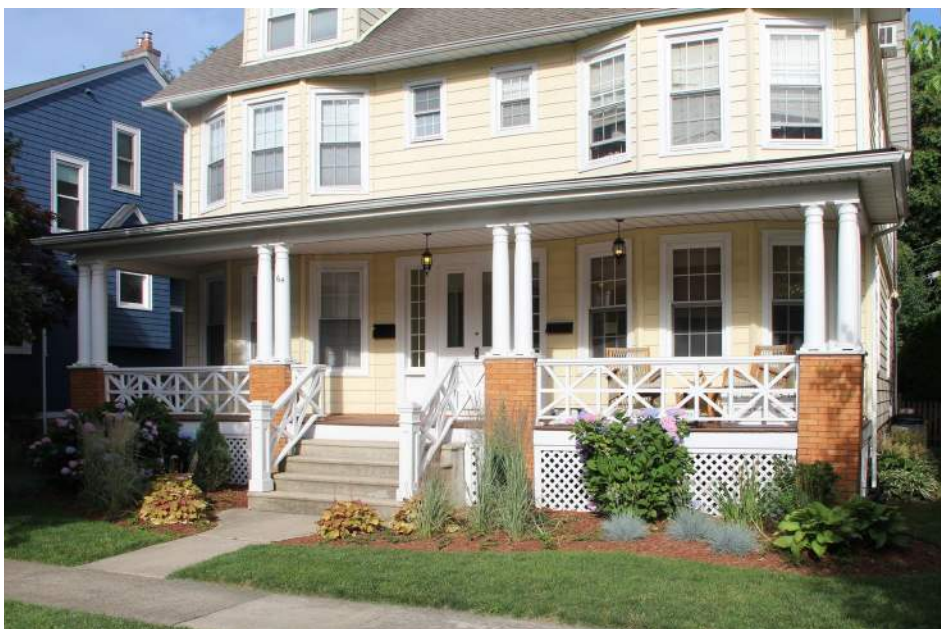
Pairs of columns atop brick piers, framed lattice, and chippendale railing panels at 64 Essex Avenue

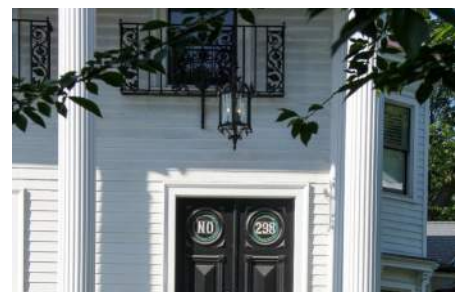
Light fixture suspended in double-height porch over front entry

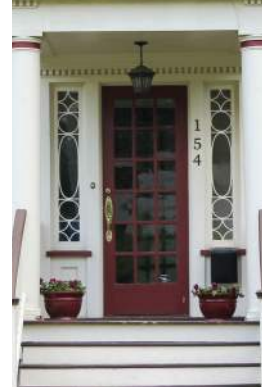
Mutli-lite door with leaded sidelites

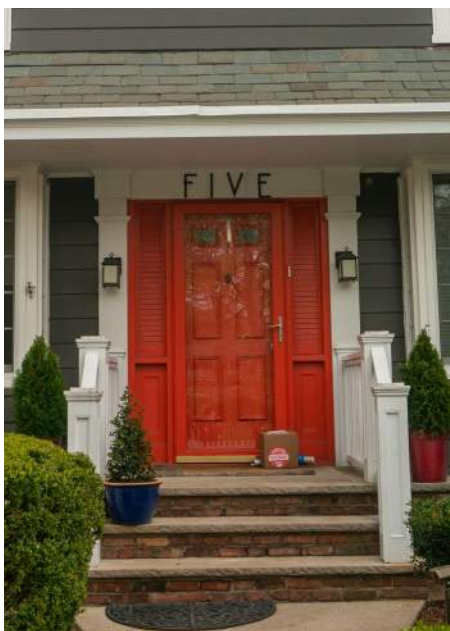
Low profile storm door finished to match

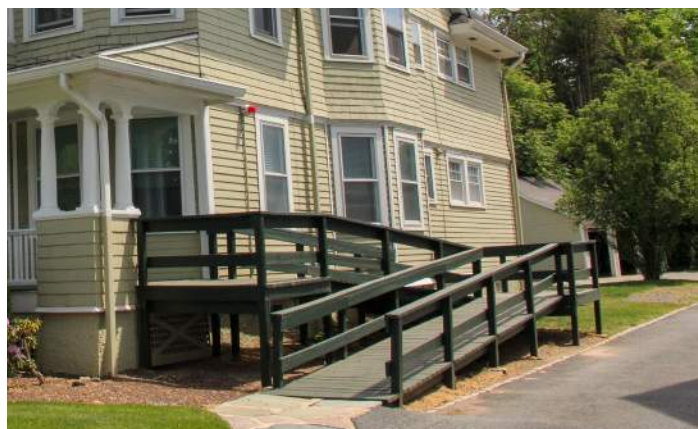
If no other options are feasible, a ramp installed in a reversible manner may be appropriate. Ramps on houses should be temporary in nature.

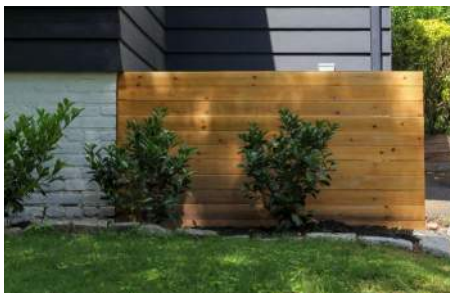
✓ Appropriate to screen mechanical equipment to reduce visibility

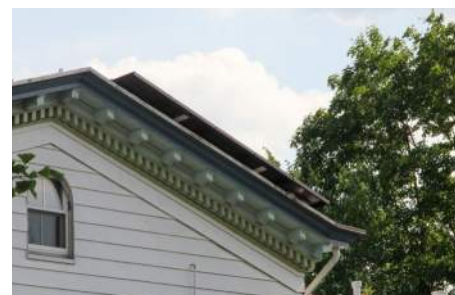
✓ Minimally visible solar panels on the rear roof of 80 Glenridge Avenue

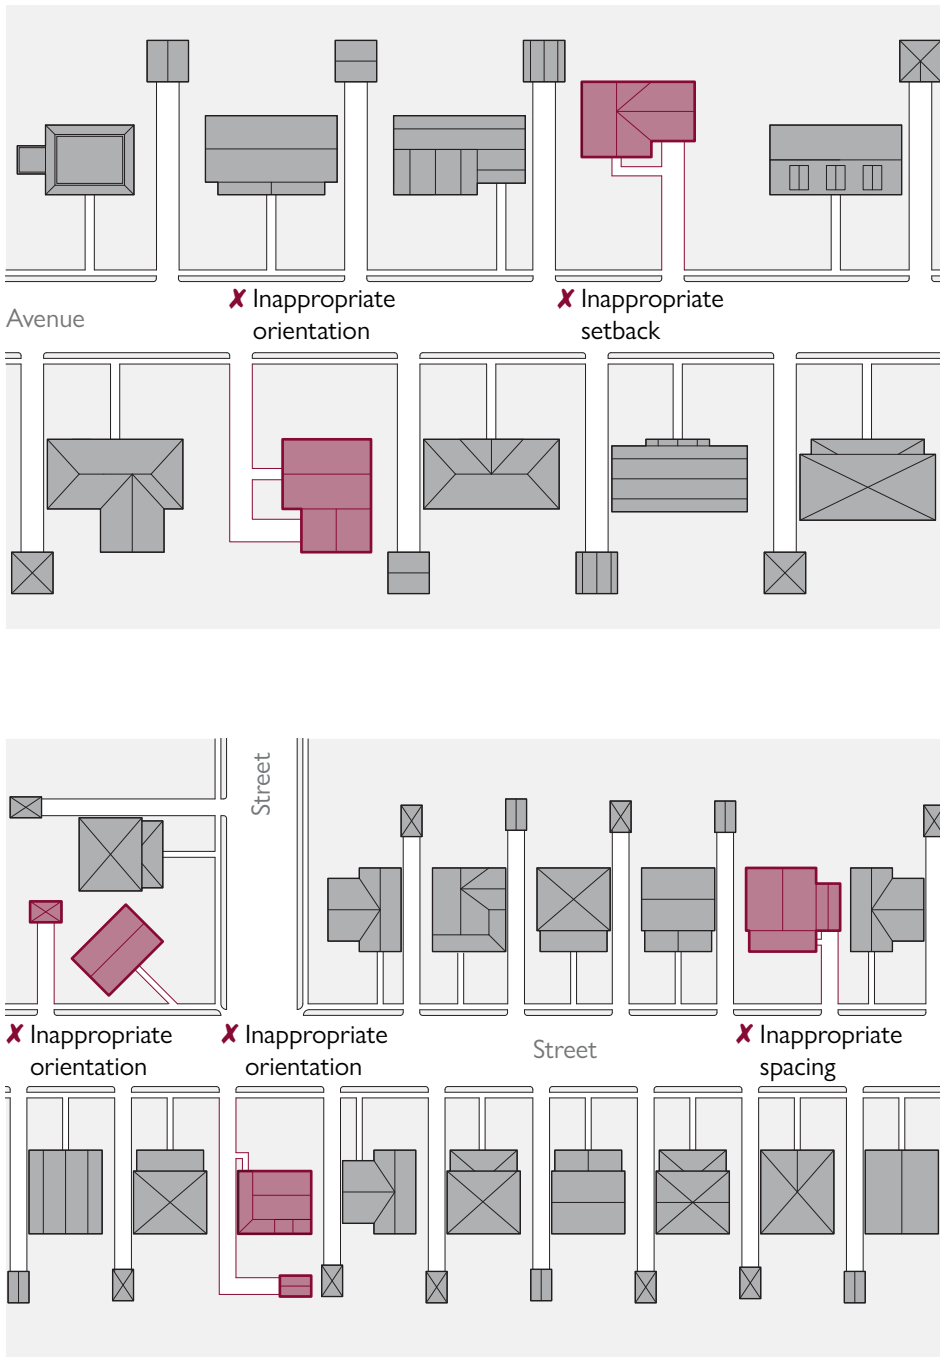
Site placement for new buildings should be compatible with the setback, orientation, and spacing, of adjacent contributing buildings.

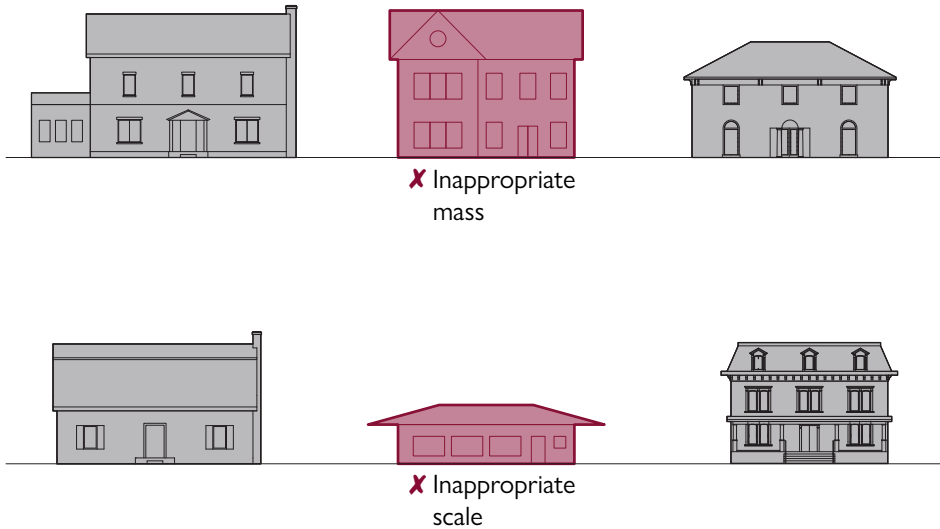
New buildings should be compatible with the height and proportion of adjacent contributing buildings.

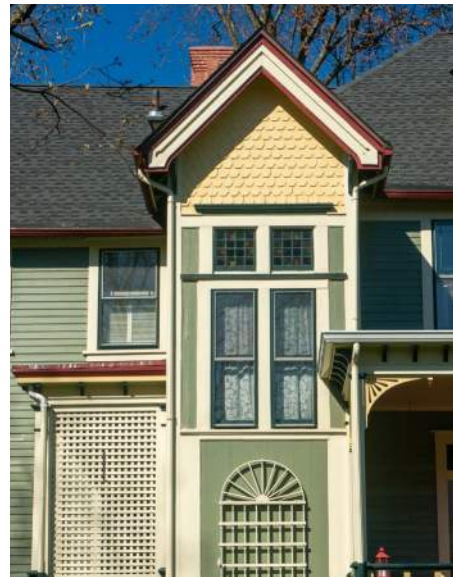
Wood fishscale shingles and clapboard siding at 34 Hillside Avenue

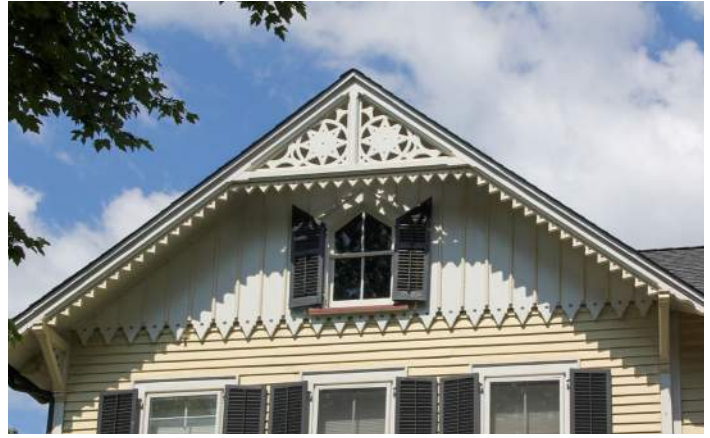
Decorative wood bargeboard and trim

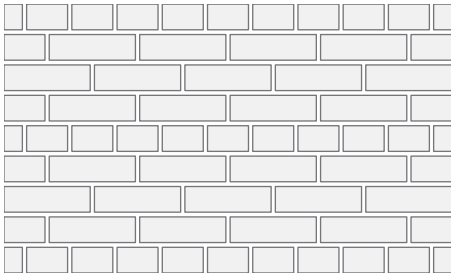
American/Common

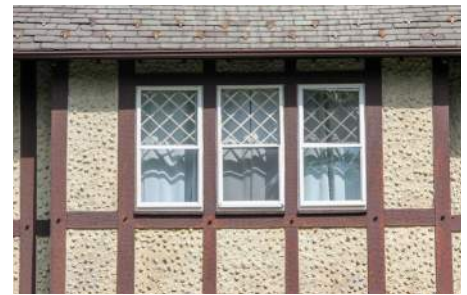
Pebble dash stucco between half-timbering

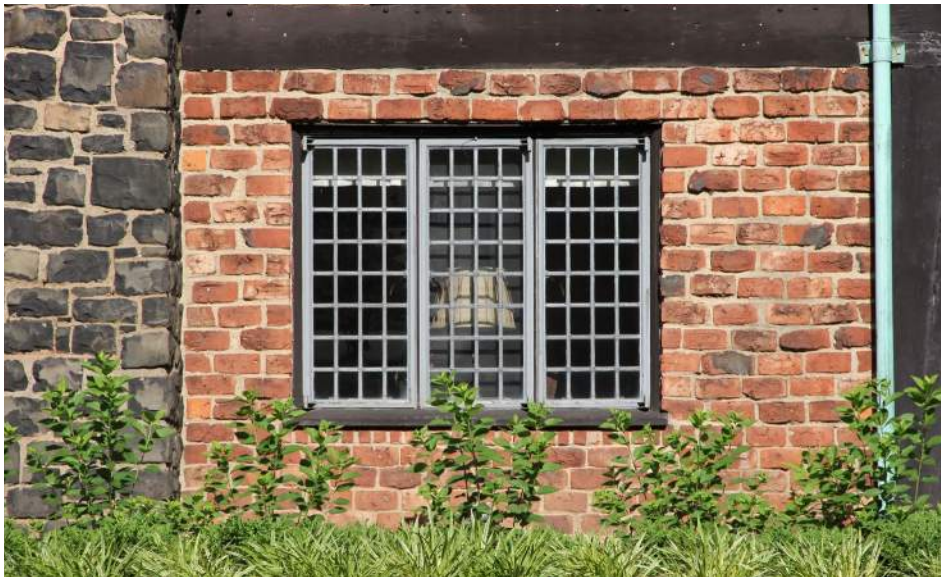
Multiple individual lites of glass set in a group of metal casement windows are a Tudor style feature of 140 Forest Avenue.

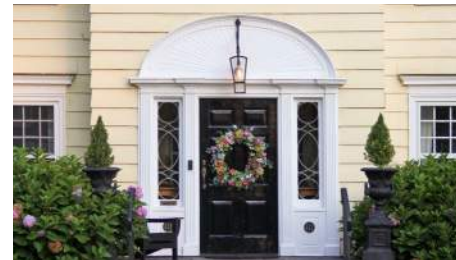
Decorative leaded glass sidelights

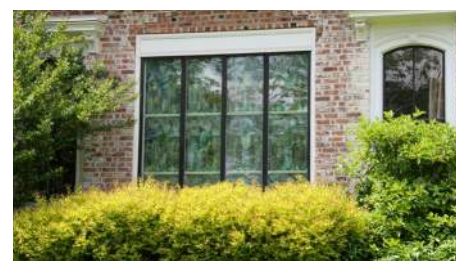
Protective glazing on the exterior side of stained glass at 298 Washington Street

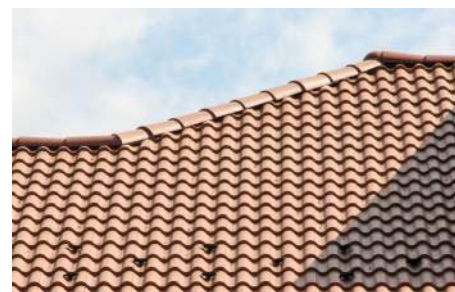
Limited instances of faux terra cotta tile are found on minimally visible and secondary roofs

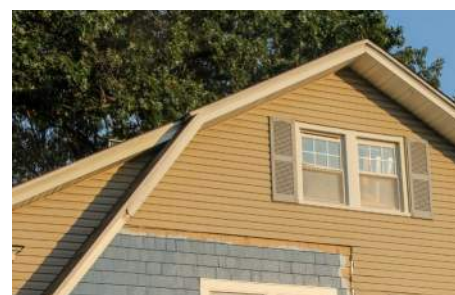
**X** Vinyl siding is not an appropriate siding treatment and should be removed
